LIGHT METAL AGE

- Academic Outreach to Advance Extrusion Industry Growth
- Metallurgical Aspects of 6xxx Billet
- The Maintenance and Upgrade of Extrusion Presses, Part II

The Key Features of a State-of-the-Art Extrusion Press

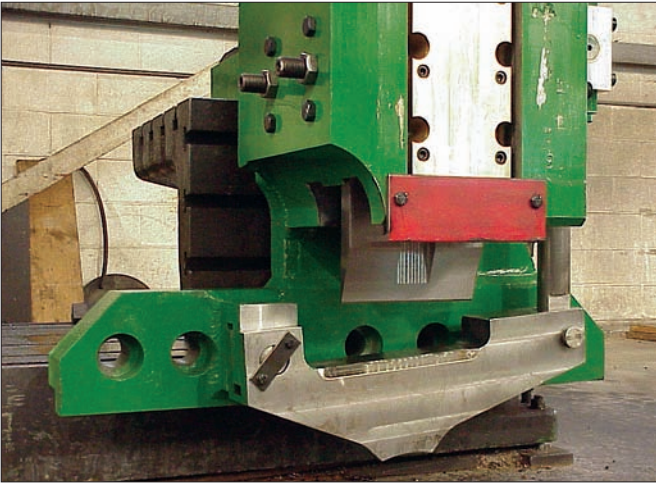
Figure 12. A sectional view of the DieGuard clamping the die ring.

ing each action of the shear. On presses equipped with die slides, the Lake Park DieGuard™ clamps the die ring providing this support (Figures 11-12).

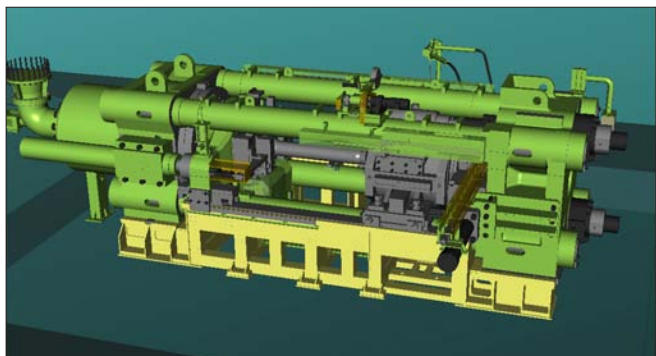
Figure 13. The full machine base of the press ensures proper alignment of the container, cross-head, and stem. Note the easy access to maintain alignment of container and cross-head from outside the extrusion press.

Constructed to withstand the earthquakes that rock some part of Japan every five minutes, the massive steel frame and boxed tie rods ensure alignment is maintained while providing access to critical components (Figure 13).

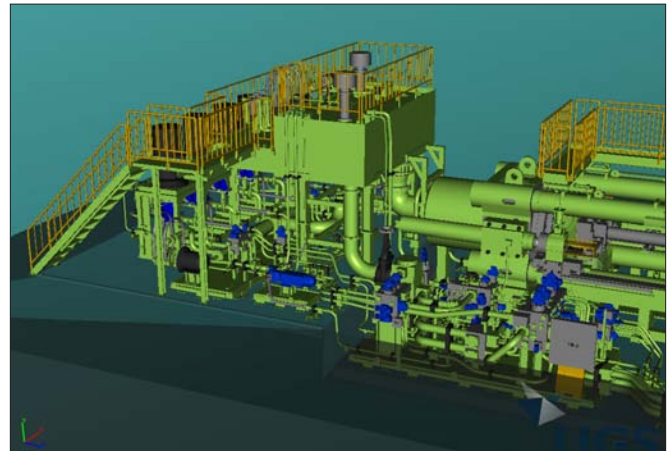
Figure 14. UBE's modern 2,750 UST press is equipped with a smaller than usual oil tank, which holds 1,600 US gallons (6000 litres) of hydraulic oil.

lization of the hydraulic fluid also enables a smaller tank to be used (Figure 14). Few presses operate for years before oil leaks become apparent, requiring the attention of maintenance personnel. Removing the main pumps from the oil tank, and placing them where they are visible and readily accessible ensures that any problems that occur can be attended to immediately (Figure 15).

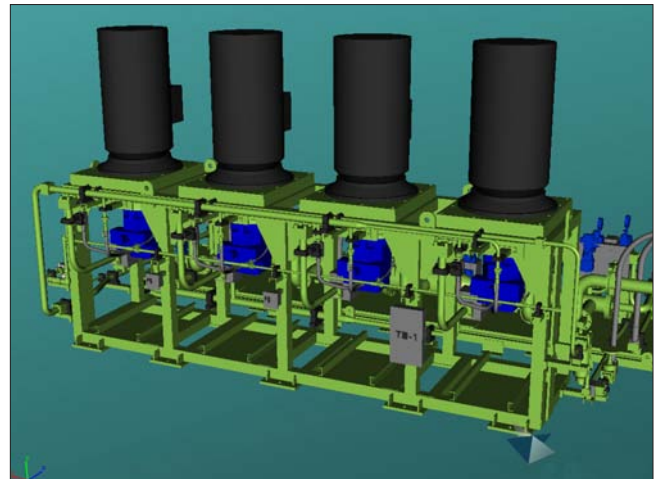
Figure 15. The main pumps are located vertically at the back of the UBE press ensuring alignment and ease of access in case of maintenance.

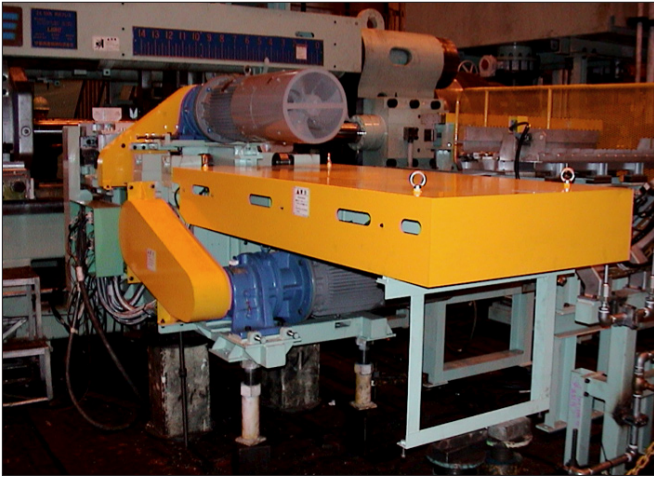
Figure 16. An electrically driven carrier moves the billet to the center-line and inserts it into the container.

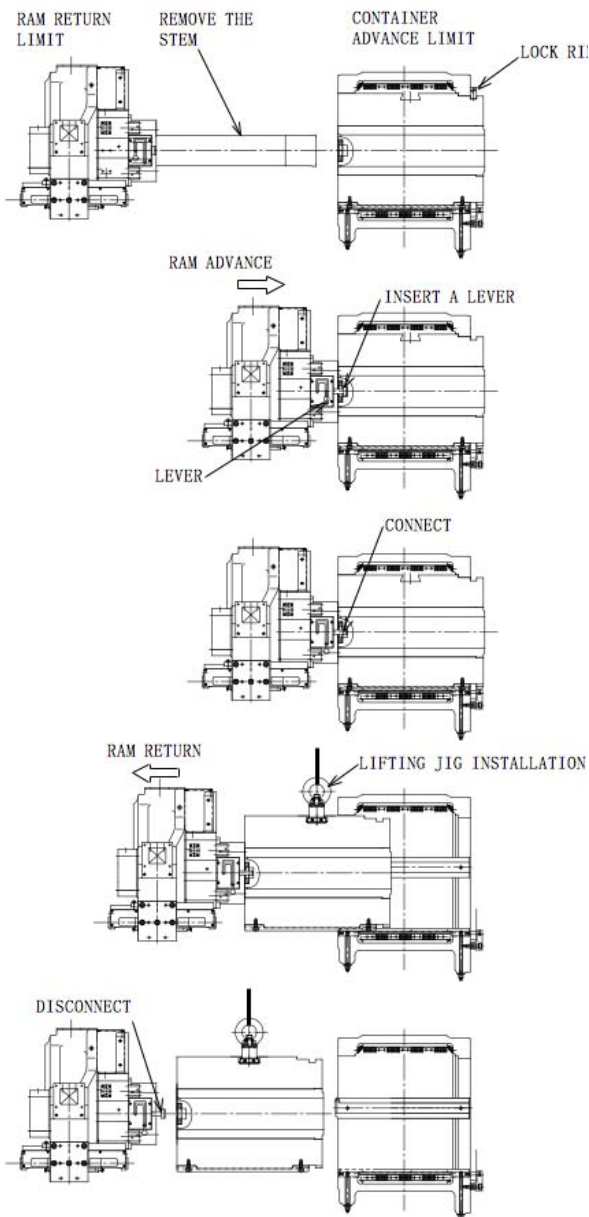
Figure 17. The steps required for a quick change of a container.

replacement parts, it has been shown that a trained press crew can change the container and stem in less than ten minutes (Figures 17-18).

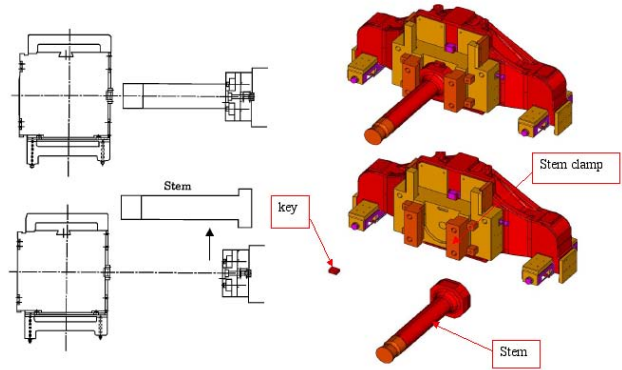
Figure 18. UBE's design has only four bolts that need to be loosened to remove the stem, thus the container and stem can be changed very quickly and down time is minimized. Accurate alignment of stem and container is maintained using electronic sensors.
